# BELZONA UPGRADES FLOOR IN FOOD PREPARATION AREA

ID: 1596

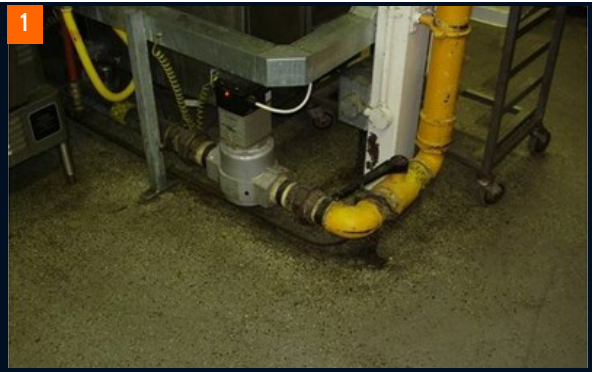
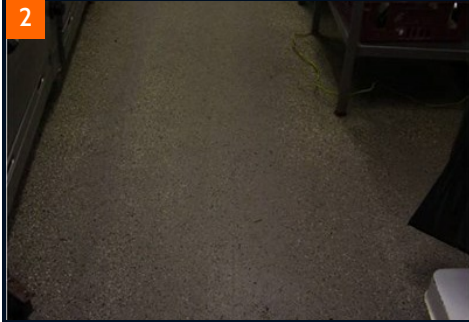
The floor was slippery creating a health and safety issue. In addition the concrete was being damaged around drains.

1. Floor Problem Area
2. Floor Problem Area
3. Completed Floor Application
4. Completed Floor Application

The application was carried out in accordance with Belzona Know-How System Leaflet FPA-3. The concrete was abraded to remove the existing coating before applying the 2 coat Belzona® 5231 system by roller.
