# BELZONA REINFORCES TANK AT STEEL MILL

Corrosion of safety immersion tanks in the coke manufacturing plant

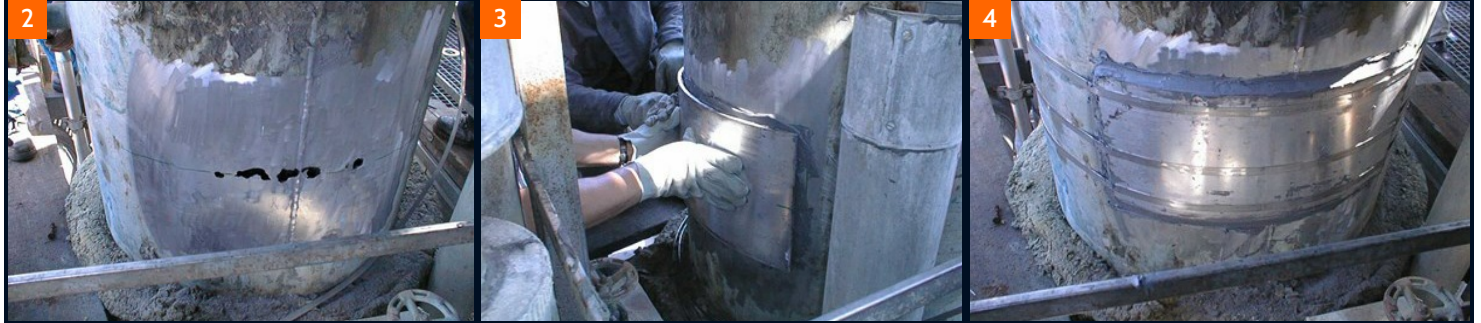
These tanks were damaged around the connection and the walls through the chemical attack of the contained medium (coke gas in water) and local steam. The temperatures ranged from 50°C to 104°C

1. The corroded tank
2. Preparation
3. Fitting the plate
4. Finished application

Application was carried out in accordance with Belzona Know-How System leaflet TCC-1. A formed section was made up. Belzona® 1111 was then applied to both surfaces and then assembled, using metal strapping to hold in place whilst the Belzona cured. Excess material was used as a fillet around the plate. After completion of cure the straps were removed.

The Belzona repair provided a stress free repair to the corroded areas. In addition to plate bonding a corroded stub pipe was also repaired (see KHIA Vol xxxxxxxx)
