# BELZONA TAIL SHAFT PROTECTION

ID: 16

(Two) 13 meters long and 0.32 meters wide tail shafts on an exploration boat.

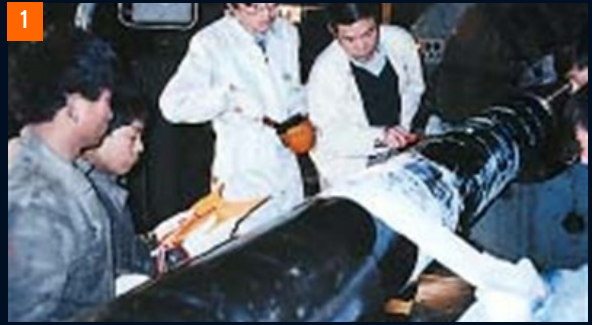
1. Application in progress.
2. Shaft is coated.
3. Tail shaft being installed.

Due to the change of bronze bush and corrosion from sea water a new protective coating was required on the shaft. Since the shafts were very long, flex vibration was a concern. A flexible protective system was used.

Application was carried out in accordance with a modified version of Belzona Know-How Leaflet SOS-6.
