# BELZONA SAVES AGRICULTURAL CHEMICAL COMPANY \$3 MILLION

10 ft. diameter x 12 ft. long filter drum used to manufacture Aureomycin

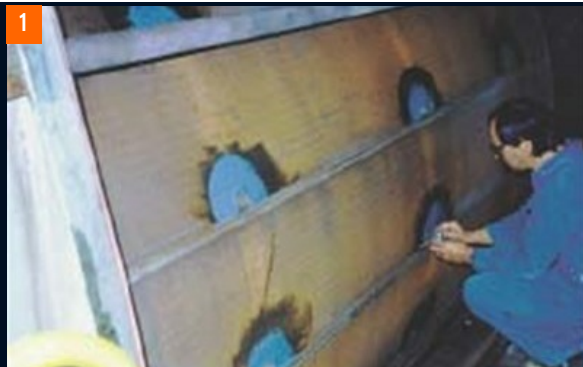
Leaks developed at the welds joining the vacuum lines to the face of the drum. The inside diameter of the drum was so deteriorated that there was some flexing at the drum face.

1. Belzona 1221 around pipe, Belzona 2311 on the drum around the Super E Metal patch
2. Beginning Belzona 2311 patches
3. Completing Belzona 2311 over Belzona 1221

After six weeks, the customer decided to check the repairs, believing that they were probably beginning to fail. Six repair areas were ground off, and no problems were observed. They were re-done as before, and the drum returned to service, saving the company over \$3 million.
