# BELZONA REPAIRS STUB PIPE AT STEEL MILL

Corrosion of safety immersion tanks in the coke manufacturing plant

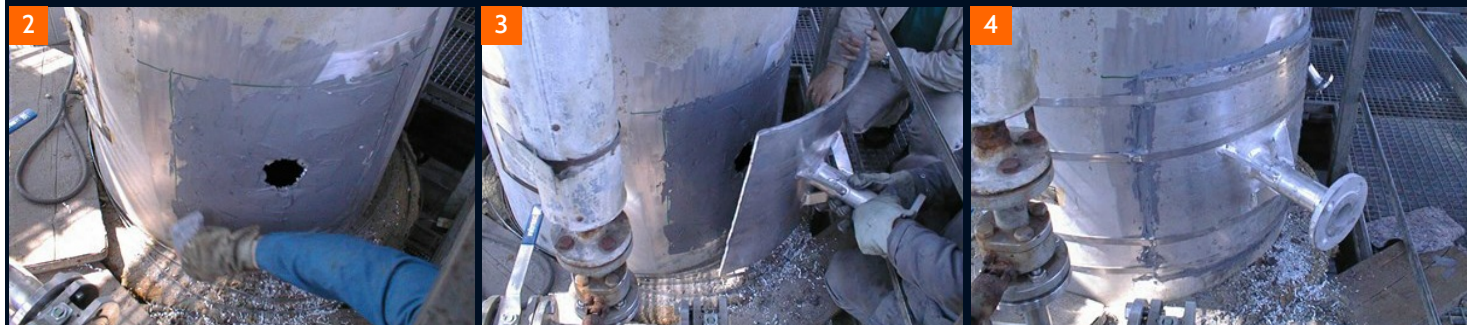
These safety immersion tanks were damaged around the connection and the walls through the chemical attack of the contained medium (coke gas and water) and local steam. The temperatures ranged from 50°C to 104°C

1. The corroded tank and pipe
2. Application of Belzona 1111
3. Fitting the plate
4. Finished application

Application was carried out in accordance with a modified version of Belzona Know-How System Leaflet TCC-1. A stub pipe welded to a formed plate was fabricated. Belzona® 1111 was applied to both surfaces and then assembled. Metal strapping was used to hold it in place whilst the Belzona cured. Excess material was used as a fillet around the plate. After completion of cure the straps were removed.
