# BELZONA GUIDES GATE VALVE REPAIR

ID: 1601

1400mm (55") NB Gate Valve

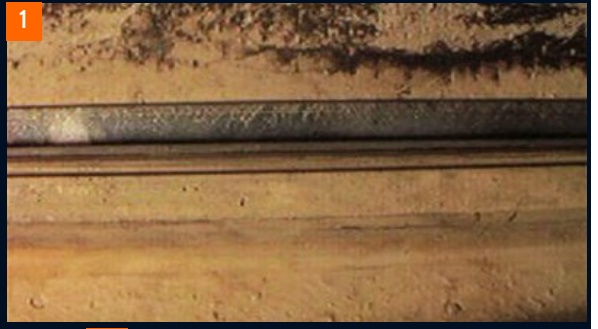
On both of the trapezoidal guides in the body there was severe metal loss caused during operation of the gate. The material loss was on average 6-8mm, occasionally 10mm (0.4"), over a length of 1600mm (63")

1. Corrosion to the guides
2. The completed application after forming
3. Refitting the valve
4. Finished repair

The application was carried out in accordance with Belzona Know-How System Leaflet VPF-4. The guides were grit blasted to remove the corrosion. Moisture was driven out of the cast iron, followed by a second grit blasting. Using forming methods the guides were rebuilt, and then deburred prior to reassembly.
