# BELZONA REPAIR MAKES A RIVETTING STORY

ID: 1602

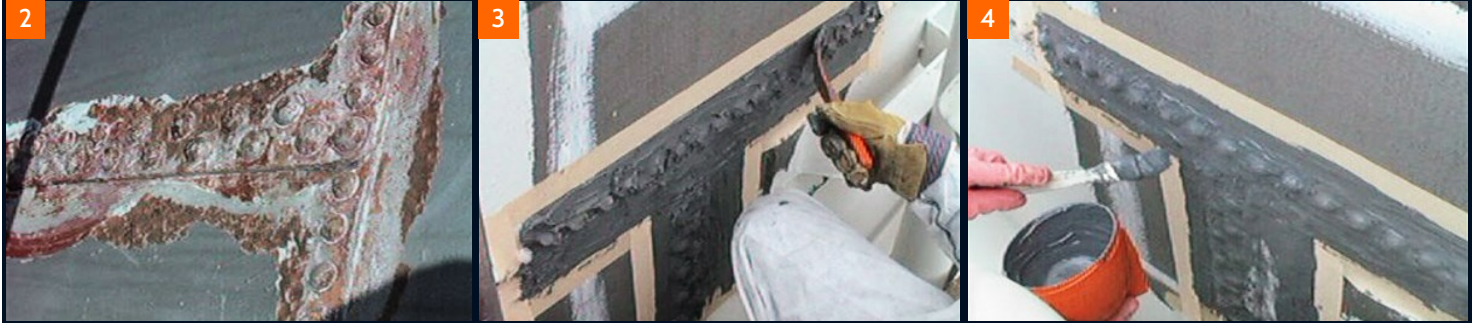
Some of the riveted seams were leaking through blistering of the anti corrosive paint. If the blisters were pierced then the fuel oil would leak out. The tank was 14m diameter and 9.85m high.

1. Overview of tank
2. Preparation of seams
3. Application of Belzona 1111
4. Application of Belzona 1321

Works were carried out in accordance with Belzona Know-How System Leaflet TCC-1. The leaking areas were prepared initially by wet slurry blasting, as the potentially explosive oil would not permit gritblasting or grinding. Belzona® 1111 was applied followed by Belzona® 9341 (Reinforcement Tape). Two coats of Belzona® 1321 completed the application.
