# BELZONA SOLUTIONS OFFER LONGEVITY TO CONTAINMENT AREA

ID: 1603

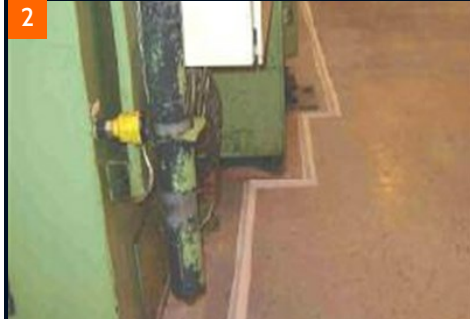
Leaking lubricant oil, cutting fluids, inks or other chemicals from production machinery which seeps/spills/runs across the floor and into pedestrian walkways. This causes environmental as well as safety problems.

1. The problem area.
2. Completed application.
3. 6 years after application completed.
4. Application date back 6 years ultimately proving the longevity of the solution.

Application was carried out in accordance with Belzona Know-How System Leaflets TCC-9&15. Prepared the surface by grinding (with dust extraction) and then marked and coated with Belzona 4911 (MagmaTX Conditioner), cut the pipe in half length ways which are then filled with Belzona 4111 (Magma-Quartz) to create containment trap.

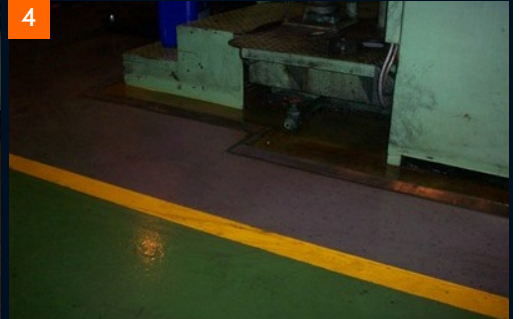
Like all other Belzona applications, it was done with minimal downtime, performed in-situ and cost-effective. It protects the environment and addresses serious safety concerns. The application has been in service for 6 years and still in perfect condition today. The client also commented that he was delighted by the level of service offered by the local team.
