# BELZONA RESTORES HYGEINE IN BOTTLING ROOM

ID: 1605

Tiled floor in bottling room.

Bottled Water Manufacturer, Perthshire, UK

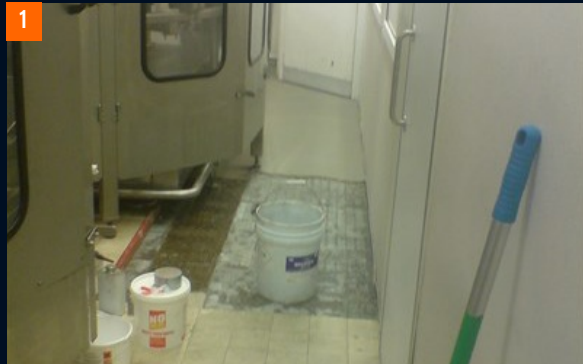
There were several cracked and broken tiles. This created a potential hygiene problem and required rectifying to remove traps for bacteria and to aid cleaning.

1. Damaged tiles being repaired with Belzona 4131
2. Floor levelled with Belzona 4131
3. Light grey Belzona 5231 being applied
4. Completed floor coating

Application was carried out in accordance with Belzona Know-How System Leaflets FPA-1 & 3. Belzona® 4131 was used to replace loose tiles and create a uniform surface prior to application of the Belzona® 5231.
