# BELZONA REFURBISHMENT MAKES FIRE ESCAPE SAFE

ID: 1606

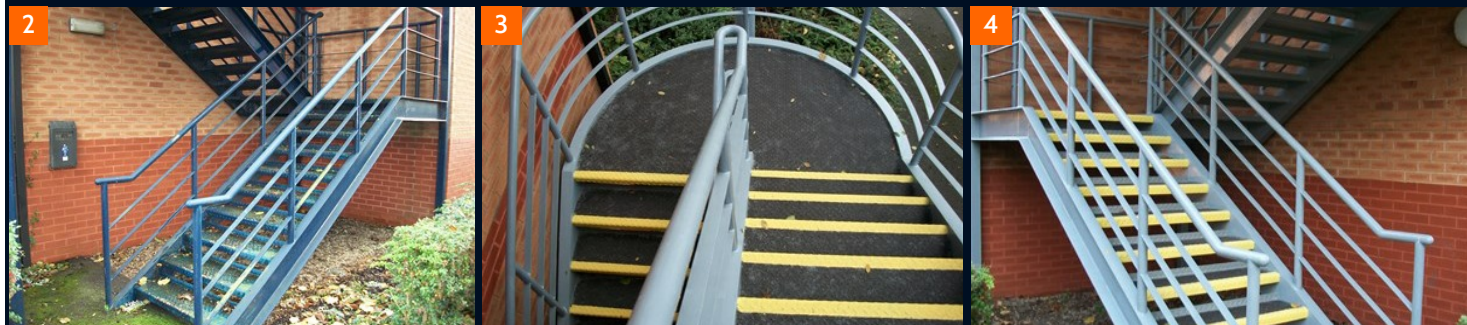
Regular foot traffic and weathering caused the steps of this fire escape to become damaged and worn and had made it a potential slip hazard.

1. Original condition of the entrance steps
2. Original condition of the entrance steps
3. The finished application
4. The finished application

Application was carried out in accordance with a modified Belzona Know-How System Leaflet FPA-8. Belzona® 4411 (Granogrip) was applied to the steps with aggregate incorporated in grey and yellow. Belzona® 5111/6111 system applied to the hand rails. Belzona® 1111 was used to smooth out corroded steelwork.

This solution was chosen as it is a long life and cost effective repair. The customer was extremely pleased with the aesthetic appearance of the application. The Belzona Grip system provides both positive grip and improved visibility to step nosings.
