# BELZONA SEALS TANK AT CABLE MANUFACTURER

ID: 1607

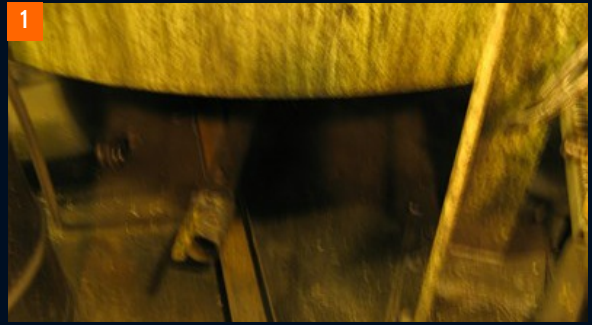
1. Exterior of tank
2. Pitted bottom after cleaning and blasting
3. Belzona 1111 seals welds and holes
4. First coat of Beige 5811 applied

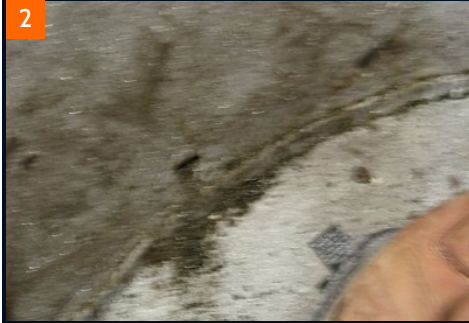
Interior bottom cone of tank was leaking resulting in safety issues. severe corrosion pitting present particularly at the welded seams.
