# BELZONA PROVIDES CORROSION PROTECTION TO HVAC AIR HANDLER

ID: 1609

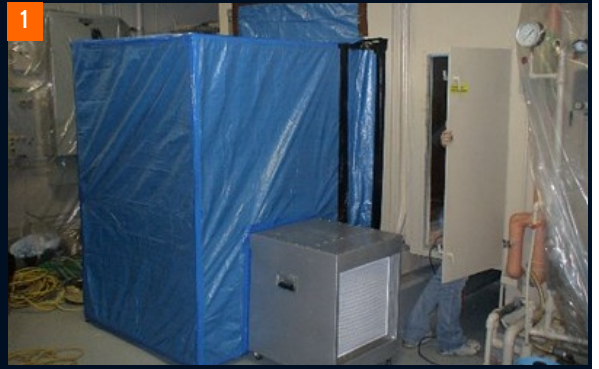
Application was carried out in accordance with Belzona Know-How System Leaflet TCC-5. A filtration system was constructed to prevent dust exiting the air handler.

1. Negative pressure system to prevent dust
2. Condition of the air handler internals
3. Work in progress
4. Two Coat Belzona 5811 System completed

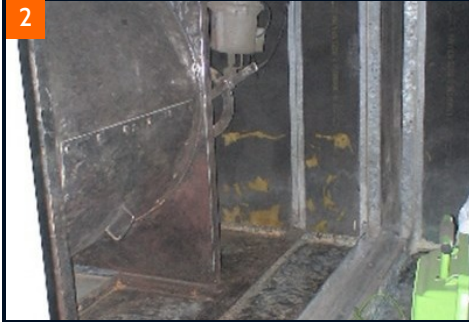
Internal corrosion had led to water leaks and these were finding there way through to the floor below.

Humidification equipment was causing severe corrosion to air handler internal surfaces.
