# BELZONA BUSHING REPAIR WITH BELZONA 1111

ID: 161

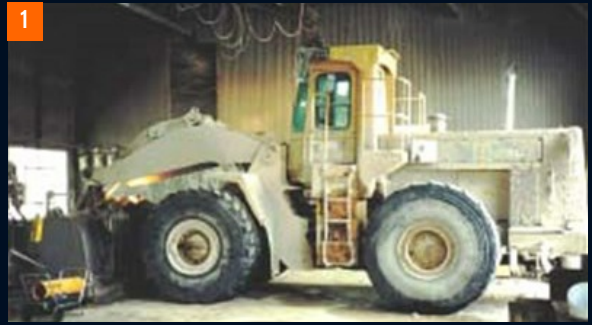
1. Cat 960 loader
2. Mandrel being inserted into the right hand bore to make the repair
3. Left side bucket pin installed and alignment pin removed

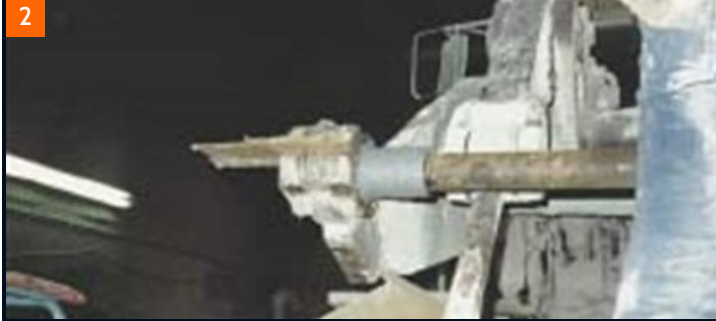
The lift arm and bucket bushing fits were severely worn.

The application was carried out in accordance with Belzona Know-How Leaflet MPT-8.

Although the repair was done inside a shed, there was no heat and temperatures dropped below freezing. An oil fired heater was used to heat the repair areas around 80°F and left on all night to cure the Belzona® 1111 (Super Metal) completely.
