# BELZONA REFURBISHMENT OF FAN HUB SAVES TIME AND MONEY

ID: 1611

Cooling Tower Fan Blade case, diameter 1854mm, width 537mm

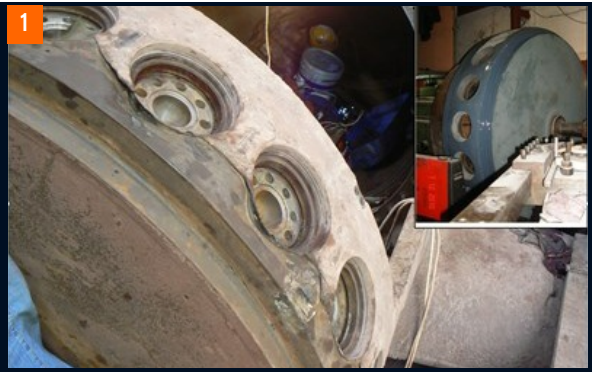
Erosion/Corrosion following failure of previous coating. If allowed to continue could cause severe damage to the fan.

1. Badly corroded case especially bottom side of fan blades
2. Wire mesh and formers cut by CNC used to achieve correct profiles
3. Application of Belzona 1111 to case with templates in place to form fan pockets
4. Finished application. Rebuild and protective coating applied. Checking each hole by installing fan blade
