# BELZONA PROTECTS POTABLE WATER TANKS

ID: 1612

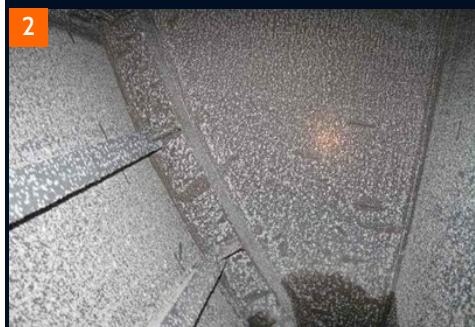
Two aluminium potable water tanks were suffering pitting corrosion that was decreasing the wall thickness. The substrate had to be protected with a potable water approved coating.

1. General view of the boat
2. Corrosion in the tank
3. Coating with Belzona 5811DW
4. Final aspect after application

Belzona 5811 DW(DW Immersion Grade)
