# BELZONA PROTECTS LARGE COLLECTION TANK

ID: 1614

Underground collection tank for waste surface water

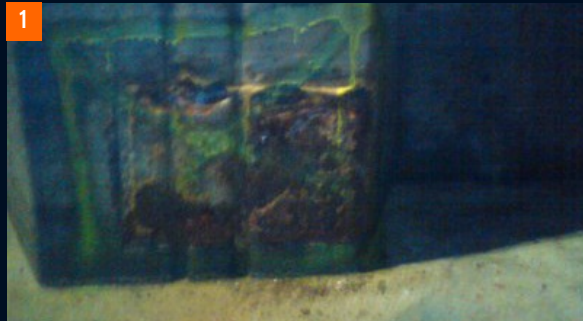
Breakdown of the original coating had allowed corrosion pitting to occur. Some leaks were occurring on the walls, particularly where wall meets the concrete tank floor.

1. Pitting corrosion on tank walls
2. Rebuild and reinforced area with Belzona 1111
3. Spray-applied second layer of Belzona 5811
4. Completed application
