# BELZONA REPLACES FAILED TANK BASE SEAL

Base of chemical storage tank

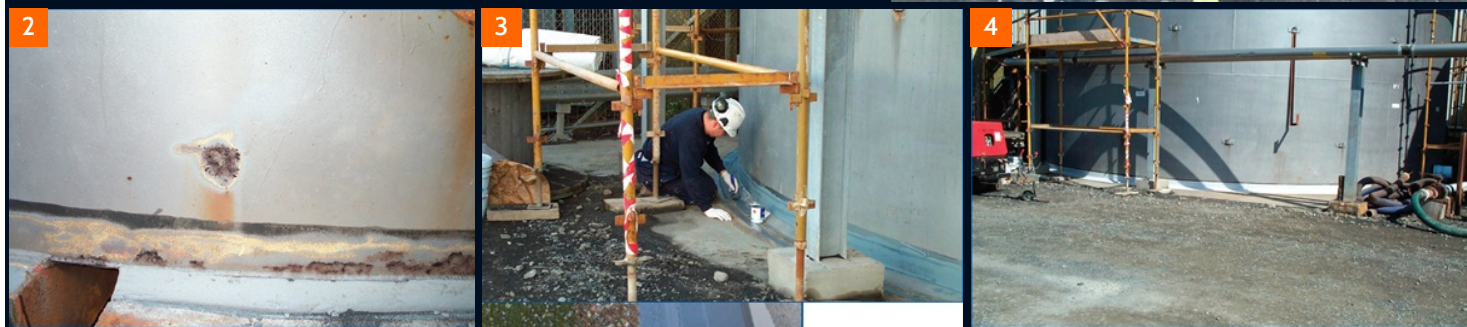
## PHOTOS

Original seal had cracked and allowed moisture to penetrate beneath tank base. Problem exacerbated by poor water shed leading to external corrosion.

1. Close up showing failure of original seal.
2. Fillet of Belzona 4131 applied
3. Application of Belzona 3111 System underway.
4. Application completed.

Traditional sealing materials had failed due to lack of flexibility. Improved water shed created by applying fillet of Belzona® 4131. Belzona® 3111 has a proven track record in waterproofing tank bases.
