# ROUTINE BELZONA TANK BASE SEALING APPLICATION

ID: 1616

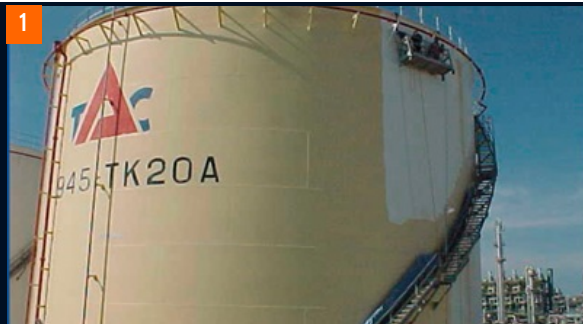
1. General view of the tank
2. Deteriorated bitumen being removed
3. Substrate conditioned
4. Belzona 3111 being applied to complete the system

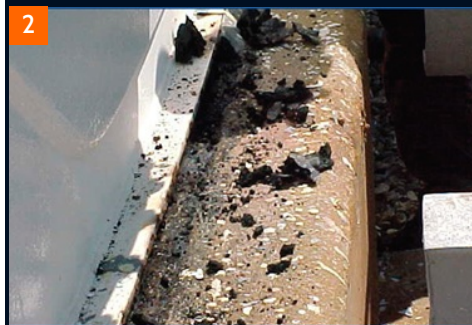
Bitumen sealant had failed to seal beneath the tank base allowing water penetration.
