# BELZONA FIRST CHOICE FOR TANK BASE SEALING

ID: 1617

An 8.5m Acrylonitrile storage tank was identified to need a more effective base seal to prevent under floor corrosion.

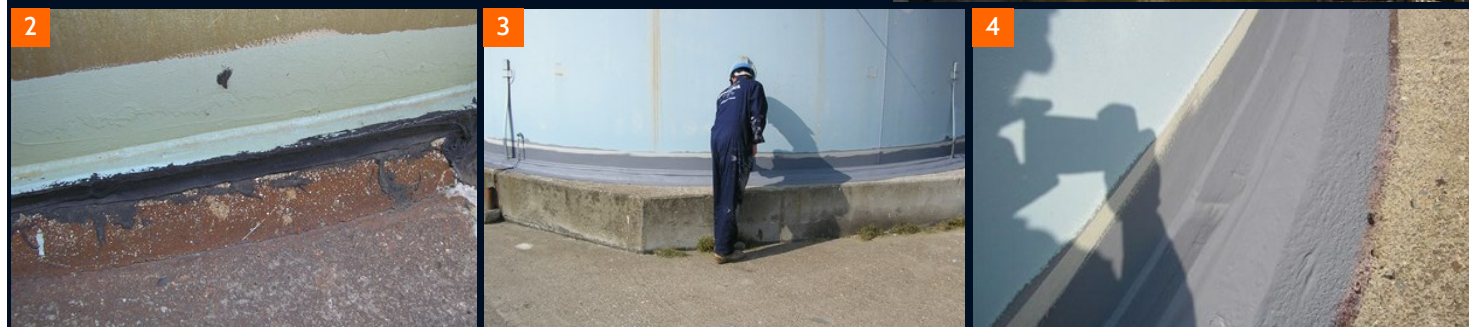
External corrosion of the tank base due to failure of the original seal.

This customer first became aware of the damage caused by under floor corrosion when they had to change a tank floor after only 10 years service. The tank in question had a mastic type base seal that proved to be ineffective. The floor was changed resulting in major financial and production losses. This company has now adopted Belzona Tank Base Sealing systems as its standard method for protecting their tanks from base corrosion.

1. General view of tank
2. Previous sealing system
3. Application in progress
4. Finished application with just the masking tape to remove

Application was carried out in accordance with Belzona® Know-How System Leaflets GSS-3.

Belzona 3111 (Flexible Membrane System)
