# BELZONA 2211 SAVES EXPANSION JOINTS AT NEW AIRPORT

Outdoor expansion joints at main passenger terminal

New Metropolitan Airport

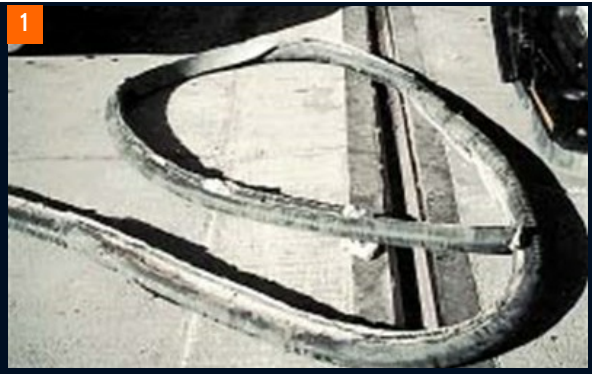
Backer rod with previous failed product pulled from joint, notice substrate chunks attached to failed product Close to the end of filling the joint The cured section, ready for service
