# BELZONA EXTENDS LIFE OF PULP BLENDER

ID: 1620

Outlet pipe of an industrial blender

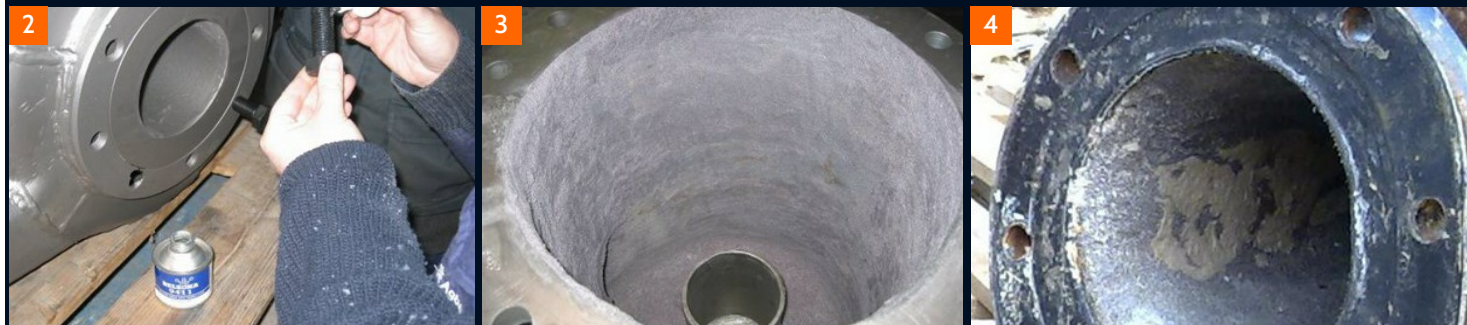
Pump and bolt threads were severely damaged by the highly abrasive stream of shredded paper pulp flowing through it

1. Pipe before application
2. Applying Release Agent to the bolts
3. Completed application
4. View of the pipe after 3 ½ years service

Application was carried out in accordance with Belzona Know-How System Leaflets ENC-2 & SHM-11. The casing threads were reformed with Belzona® 1111 using the bolts treated with Belzona Release Agent as formers. The internals of the pipe were lined with Belzona® 1812.

Prior to contacting Belzona, the company had to replace this piece of equipment every 1 or 2 years. An inspection of the Belzona lining 3 ½ years later, in August 2010 showed it was still in place and none of the metal parts were exposed. As a result, the customer asked Belzona for several similar applications.
