# BELZONA REPAIRS LEAKING HEAT EXCHANGER TUBE SHEETS

ID: 1622

Various oil & air coolers of marine vessel

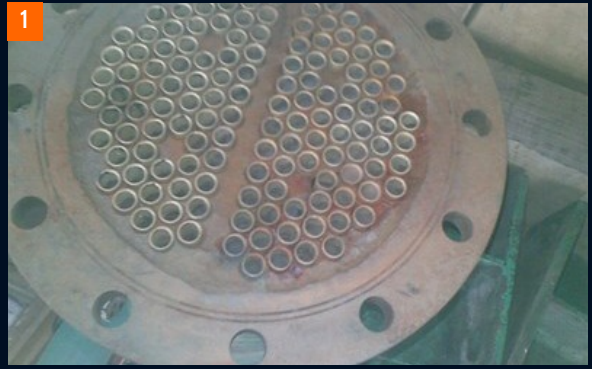
Severe erosion and galvanic corrosion between copper tubes and steel tube sheet.

1. The severe damage clearly evident
2. After grit blasting, the eroded tube sheet was rebuilt with Belzona 1311
3. The coolers after application of Belzona 1321
4. Further air coolers were also repaired
