# BELZONA PROTECTS SUGAR BEET MIXER SHAFT

ID: 1623

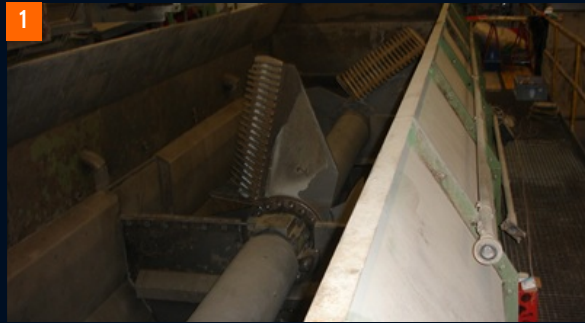
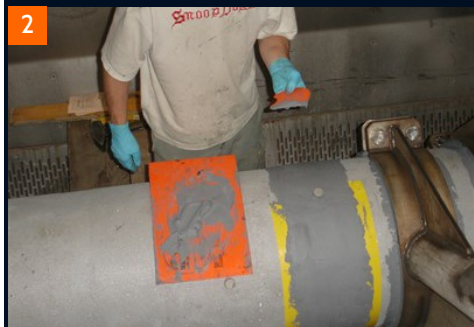
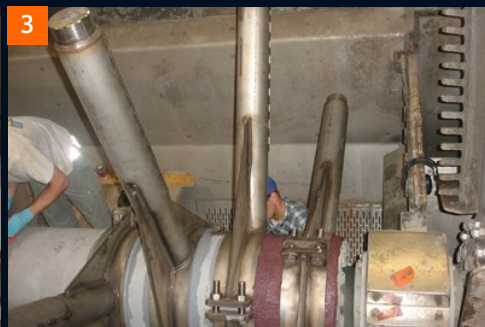
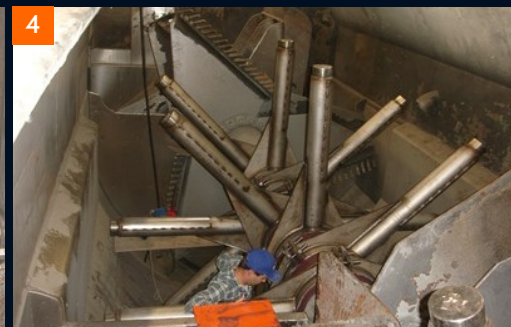
Loose particles of soil and small pieces of rock, released during the processing of the sugar beet causes abrasion on the shaft.

Mixing shaft with 46 half shells on which agitating arms were located

1. Shaft after removal of half shells and agitating arms
2. Application of Belzona 1121
3. Application of Belzona 1811
4. Completed shaft with agitating arms screwed back in place

Application was carried out in accordance with Belzona Know-How System Leaflets GSS-9 and SHM-14. Belzona® 1121 was used to create irregular shims under the half shells to ensure perfect fit onto the shaft. The exposed areas of shaft were protected with Belzona® 1811 against future abrasion damage.
