# BELZONA PUMP DIFFUSER PROTECTED

Centrifugal pump diffuser

Sewage Treatment Plant in Northern California

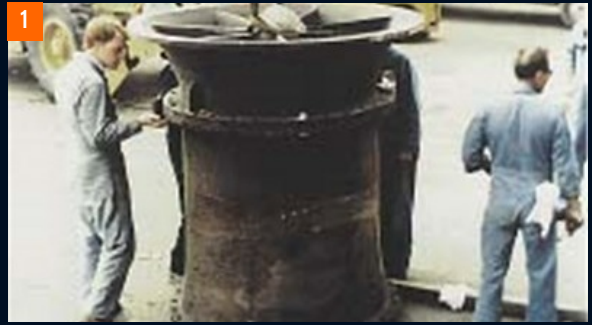
1. The diffuser removed for repairs
2. Damage on flow surface
3. Close up of cavitation pitting
4. Repairs in progress using a rotating jig to create the internal shape and dimension without machining

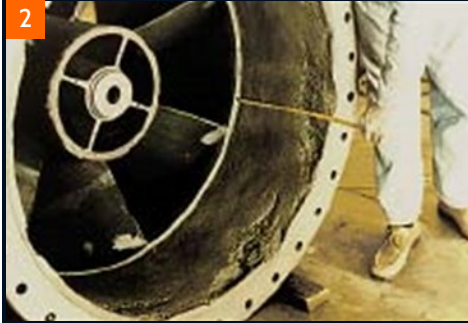
Erosion/corrosion and cavitation
