# BELZONA SEALS HEAT EXCHANGER AT METHANOL PLANT

ID: 1630

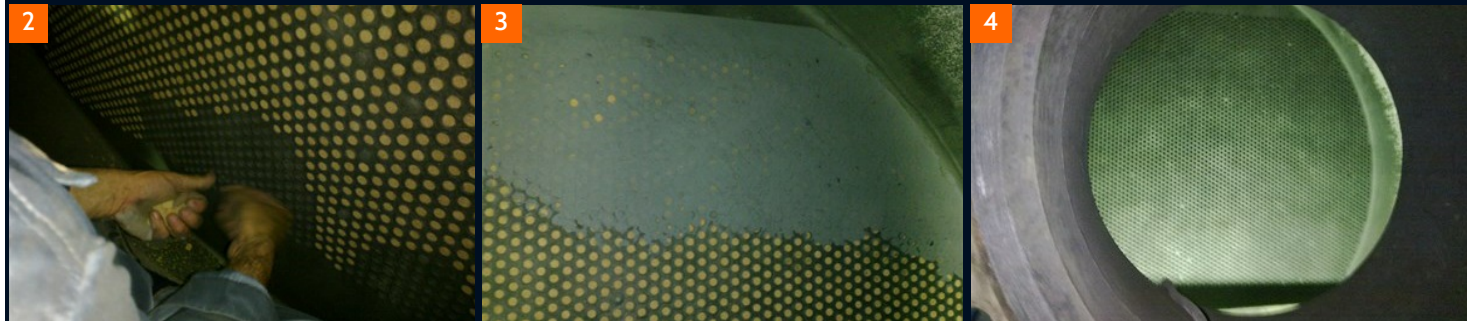
## PHOTOS

There was a lot of leakage between tubes and sheet due to galvanic corrosion.

1. Workers corking the tubes
2. Close up
3. Tube sheet face rebuilt with Belzona 1511
4. Completed application after removal of corks

Application was carried out in accordance with Belzona Know-How System Leaflet HEX-1.

The high heat resistance of Belzona® 1511 ensured long term adhesion to the hot substrate. The Belzona repair saved both time and costs over the alternative of welding or re-tubing.
