# BELZONA KEEPS COURT IN SESSION

Main air handler fan for cooling system

Courthouse, Minneapolis, MN

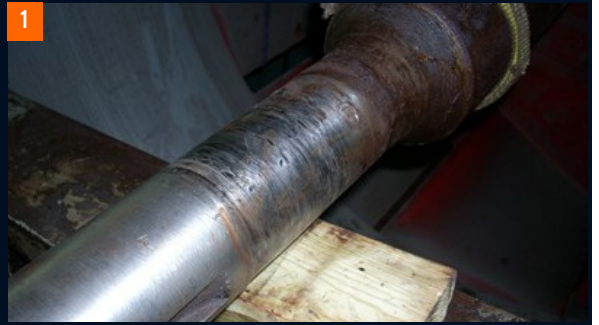
Bearing had failed scoring the 2 1/2 inch shaft. Hot weather required air conditioning to be working effectively.

1. Scored shaft
2. Surface preparation
3. Belzona applied and former secured after treating with Belzona Release Agent
4. Finished shaft with bearing reinstalled
