# BELZONA PROTECTS WET CYLINDER LINERS ON DIESEL ENGINE

ID: 1633

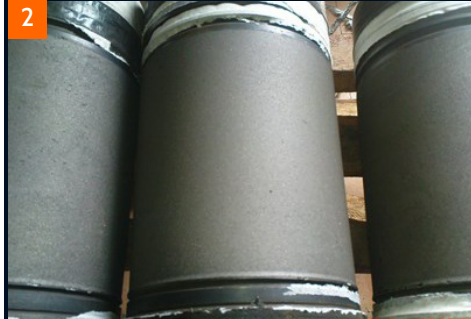
Erosion corrosion pitting on liner bodies.

1. Pitting on the body of the wet cylinder liners
2. Cylinder liner after grit blasting
3. Checking the application thickness
4. Some of the 24 units repaired and protected with Belzona

The application was carried out in accordance with Belzona System Leaflet ENC-6. Pitting was filled with Belzona® 1311 before providing overall erosion corrosion protection with Belzona® 1391 coating.
