# FOUR BELZONA REPAIRED CONDENSERS STILL IN SERVICE AFTER 17 YEARS

Four main condensers with a total of eight tube sheets

Power station, Thailand

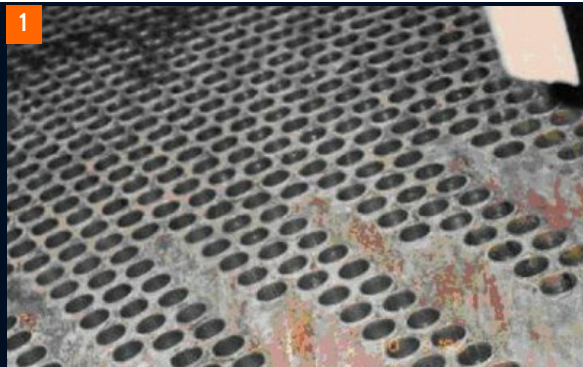
Corrosion pitting had occurred around the tubes as a result of bi-metallic corrosion effects and the chloride content of the used river water.

1. Corroded tube sheet before application in 1993
2. Standard application underway. Special care was taken to prevent contamination of substrate)
3. Inspection in 2005
4. Inspection in 2010

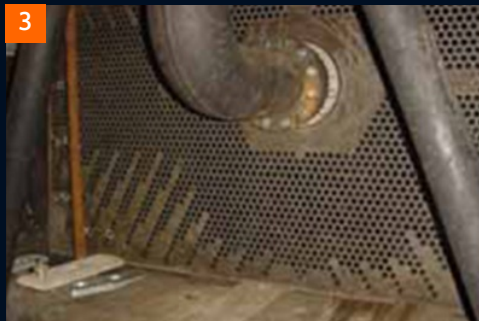
Since the application of the coating, regular inspections took place which proved the excellent performance of the Belzona coating. In 2005, the complete coating of the tube sheet was still intact without showing any signs of degradation. A further inspection in 2010, after 17 years in service, also showed that the coating was still in a good condition. Only 10% of the surface was locally damaged due to mechanical damage. These areas were quickly repaired with Belzona before the tube sheet was put back into service.
