# BELZONA REPAIRS AND PROTECTS HOSPITAL TUNNEL

ID: 1635

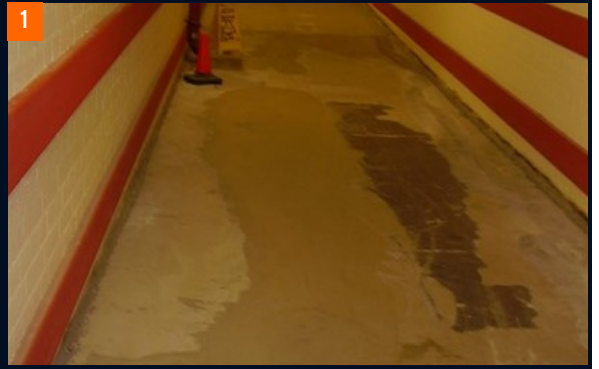
Due to constant heavy traffic using the connecting tunnel between the two hospital wings, the floor had become worn and uneven. As this is the only direct route between the two parts of the Hospital, it was essential that it was open every day from 6am.

Damaged and uneven floor in connecting tunnel between two hospital wings.

1. Damaged floor
2. Damaged floor with first coat of Belzona 5231
3. Completed application

Application was carried out in accordance with Belzona Know-How System Leaflets FPA-1 & 8. Belzona® 4131 was first applied to resurface the damaged concrete. Following this, two coats of Belzona® 5231 (incorporating an additional 10% aggregate) were applied to provide protection to the surface together with positive grip.
