# BELZONA UPGRADES MORTUARY FLOOR

ID: 1636

Hospital Mortuary, Glasgow

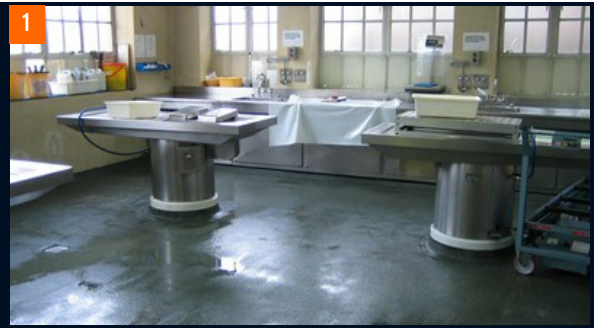
As the floor was regularly washed down, it had caused the floor to become damaged and uneven causing water to gather in certain areas.

1. Damaged floor
2. Examination table base screeded with Belzona 4131
3. Floor repairs using Belzona 4131
4. Completed application after application of Belzona 5231
