# BELZONA SEALS PLANT ROOM FLOOR

ID: 1637

Boiler plant room of a hospital

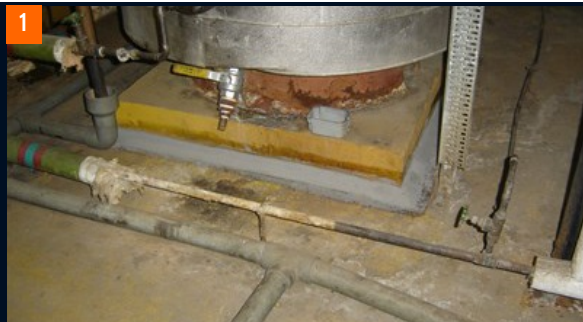
Water was leaking through the floor to the operating theatres below.

Damaged floor Belzona 5231 application  
starting Completed application  
Completed application

Application was carried out in accordance with Belzona Know How System Leaflet FPA-8. The floor was first diamond ground and then two coats of Belzona® 5231 (SG Laminate) applied.
