# BELZONA KEEPS MANUFACTURER COOL

ID: 1638

Cooling tower at this major manufacturer of Aluminium castings for the motor industry

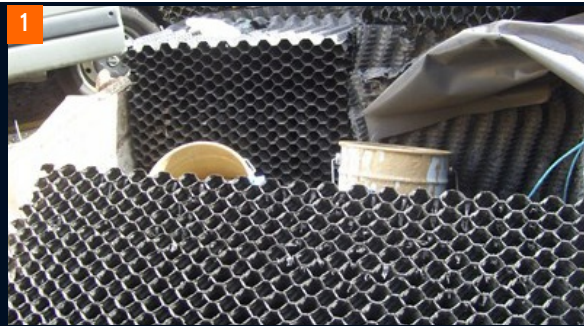
1. Packing removed
2. Tented up and ready for application
3. Completed application
4. Floor area completely protected with Belzona 5811

Application was carried out in accordance with Belzona Know-How System Leaflets TCC-1 & TCC-5. After removing roof and removing all the packing (used to increase surface area), Belzona® 1111 was used to bond doubler plates over holed/thinned areas before the entire surface was protected with Belzona® 5811.
