# BELZONA, THE EASY WAY TO SEAL SILOS

ID: 1639

Two 17 metre high, 6 metre diameter silos for storage of Lime and Chalk

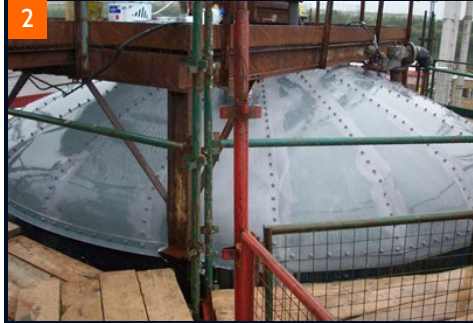
Corrosion and mechanical damage had opened up the bolted joints allowing rain water to wash dirt through the joints leading to contamination of the lime and chalk stored in the silos.

1. Silo scaffolded and ready for work to commence
2. Initial application to problem areas
3. Silo roof fully protected
4. Completed application

Application was carried out in accordance with Belzona Know-How System Leaflet RPA-1. After preparing substrate with grinders, Belzona® 3921 (GSC Conditioner) was applied before completing the application with two coats Belzona® 3111.
