# PRISON MUSEUM STEPS MADE SAFE WITH BELZONA

Stairway into the prison museum

Prison Museum in the Bay Area of California

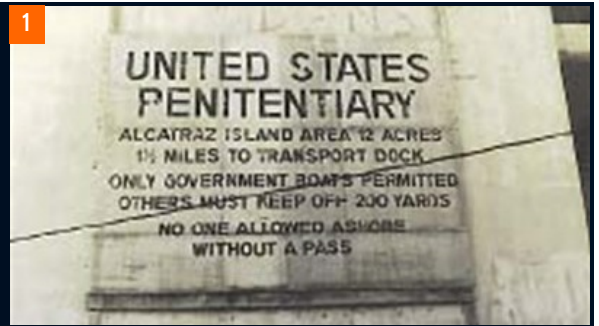
Severe weathering damage caused an unsafe condition for tourists visiting the site. Exposed rebar was causing the damage to accelerate.

1. Sign at entrance
2. Damage on underside of stairs, note exposed rebar on landing
3. Completed repair to stair
4. Repairs were also made to chipped concrete on stair tops

The application was carried out with Belzona® 4111 (Magma Quartz) molded in place with formers. Today, Belzona® 4141 (Magma Build) would make for a faster, easier repair. The hazardous conditions were eliminated and the repair is still in service as of March, 1996.
