# BELZONA REVISITS LEAKING PIPE

ID: 1640

Cooling water pipework

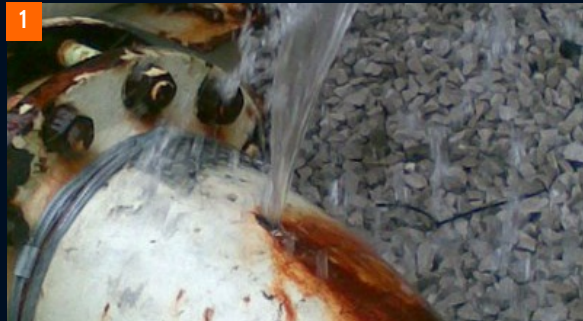
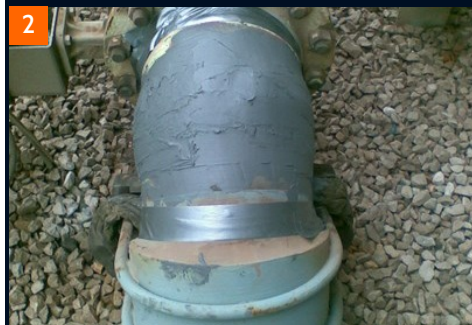
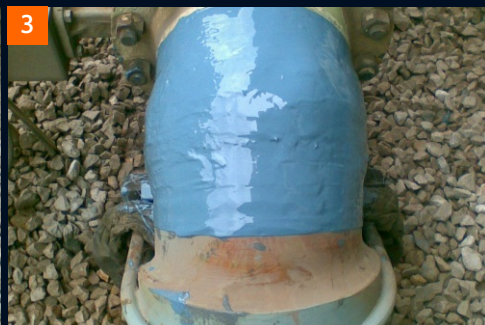
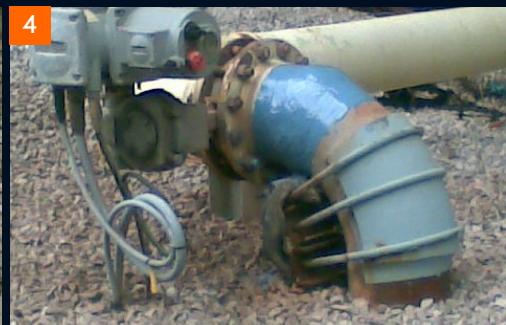
## PHOTOS

Leaking pipe was affecting efficiency of the cooling system. Back pressure meant repair had to be carried out live and to a very tight schedule. Adjacent section of pipe had previously been repaired with Belzona.

The leak Belzona 1111 wrap completed  
Completed application protected with  
Belzona 1341 Note earlier repair  
immediately below latest repair

Application was carried out in accordance with Belzona Know-How System Leaflet VPF-11a. After temporarily stemming leak with Belzona® 1291, Belzona® 1221 was applied to give additional strength before grit blasting and applying a Belzona® 1111 wrap. Belzona® 1341 was applied over the top to provide corrosion protection to exposed section of pipe.

Just 2 hours after completing the repair, the full pressure was restored. This repair has now been in service 3 years with the earlier repair now 7 years in service.
