# BELZONA HELPS KEEP THE FARMS FREE FROM FLOODING

ID: 1641

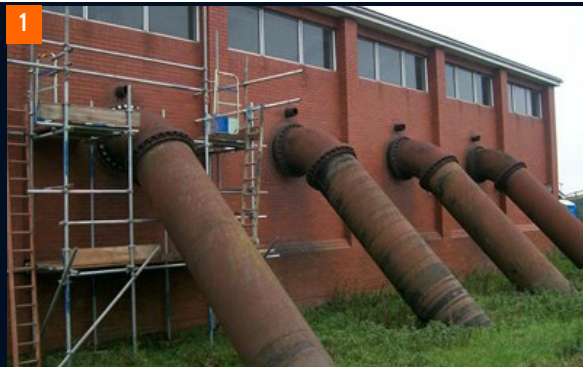
Pumping station used to regulate the water table in the surrounding low lying farmland. There are 4 pump sets that transfer water from the land into the nearby river to prevent flooding.

1. General view of the pumping station with the 4 outlet pipes
2. The damaged pipe
3. Belzona 1291 applied to stem leak
4. Pipe completely wrapped with Belzona 1161

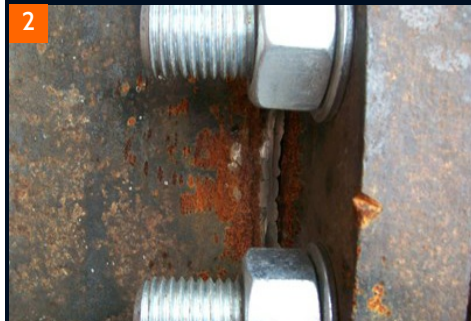
Crack on one of the 900mm outlet pipes was jeopardising operation of the pump set. Due to the time of year and high risk of flooding it was deemed unacceptable to take the set offline and carry out a conventional repair.

A weld repair had already been tried and failed. The Belzona repair allowed flood defences to continue until flood risk was lower and pipe could be dug out and replaced.
