# BELZONA OVERCOMES PROBLEM OF LEAD THEFT

ID: 1643

Window canopies on roof of a local school

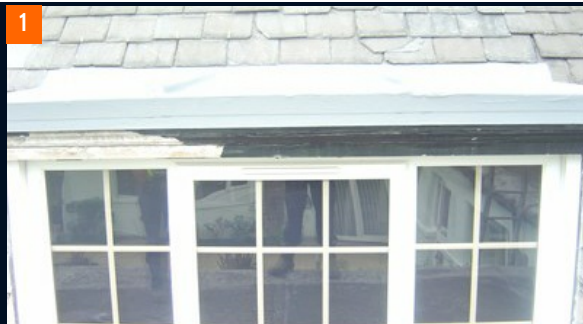
This school had recently suffered from theft of the lead from their roof. The damage was so extensive that if not addressed, it would lead to structural defects resulting in a potentially disruptive high cost maintenance repair.

1. Window before application
2. General view of the roof
3. Application completed
4. Application completed

Application was carried out in accordance with Belzona Know-How System Leaflet RPA-2. Roof was felted prior to sealing with fully reinforced Belzona® 3111 system.

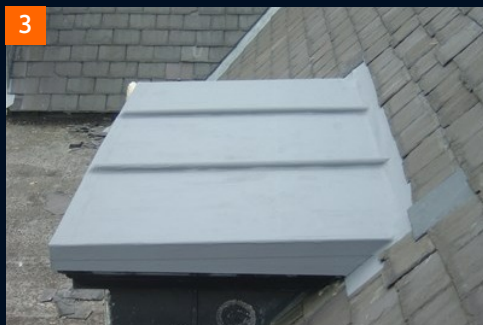
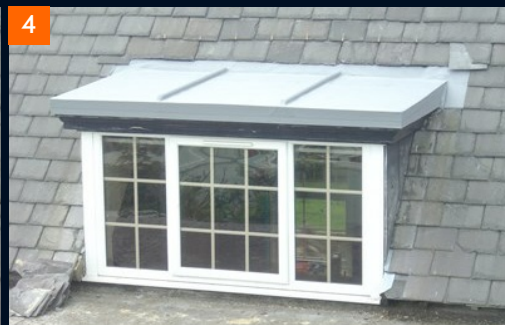
The repairs were completed in less than one week. Revisiting the application in 2010, the school has not experienced any further problems, and the repair is still in excellent condition.
