# BELZONA REPAIRS ROOF AT PRESTIGIOUS UNIVERSITY

ID: 1646

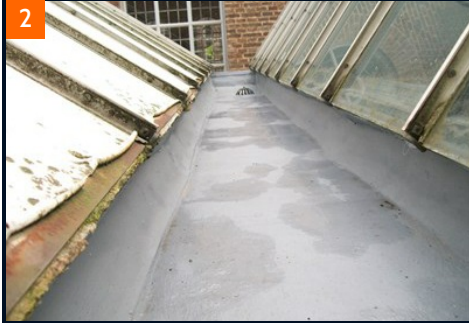
The mineral felt roof and gutters were in poor condition with various areas leaking directly into the reading room below where many historic books are stored and read daily by students.

1. Damaged gutter prior to the application
2. Gutter coated with Belzona 3111
3. Leaking roof area
4. Roof coated with Belzona 3111

The University had experienced problems before with students complaining about the smell and feeling ill due to competitors solvent-based roofing products being used on other University buildings. Belzona® 3111 fully reinforced system was applied without disruption to the daily use of the library reading rooms below.
