# BELZONA SEALS ROOFTOP EXPANSION JOINTS

ID: 1648

Pond on roof of university

University, Leeds, UK

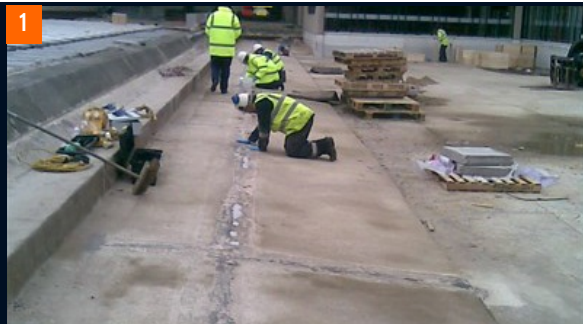
Pond had been drained for refurbishment and concern was expressed over the waterproofing of the expansion joints.

1. Roof showing signs of damage
2. Close up of the damage
3. Application in progress
4. The application completed

Application was carried out in accordance with Belzona Know-How System Leaflets FPA-1 & RPA-1. After cleaning and drying, all loose concrete was removed and repaired using Belzona® 4111 followed by two coats of reinforced Belzona® 3121 to bridge the joints.
