# BELZONA REPAIRS LEAKING SCHOOL ROOF

ID: 1649

Low pitch zinc sheet roof at school.

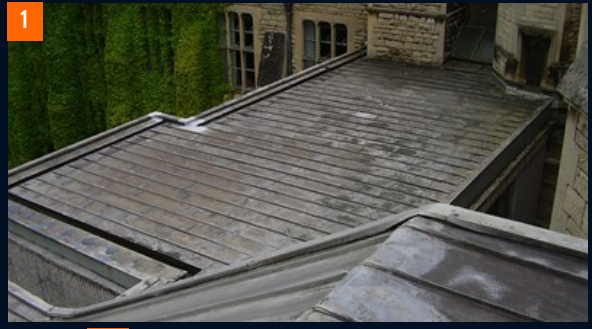
The roof was leaking at the joints, seams and gutters.

1. Prior to application
2. Roof part 1, the completed application
3. Roof part 2 before application
4. Roof part 2 completed

Application was carried out in accordance with Belzona Know-How System Leaflets RPA-1 & 6.
