# BELZONA PERFORMANCE IMPROVEMENT PROGRAM (PIP) BOOSTS OUTPUT

ID: 165

Water transmission pumping station

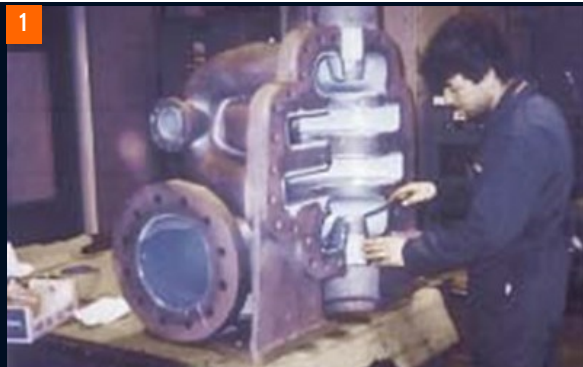
Reduced output from booster pumps which required standby unit to operate continuously to provide adequate flow

1. Pump house showing pump unit
2. Performance improvement information
3. The completed application following refurbishment

Due to the reduced output of the pump units and the increased demand for water, each unit was removed for inspection and repairs and coating were carried out in line with Belzona P.I.P. recommendations. The pumps were then tested prior to re-installation on-site where dramatic results of all five units were observed. Under normal demand only three pumps are required instead of five. Flow has increased from 65 liters/sec. to 125 liters/sec. at the required pressure. Power consumption was reduced by 5%. Pump efficiency increased by 24%.

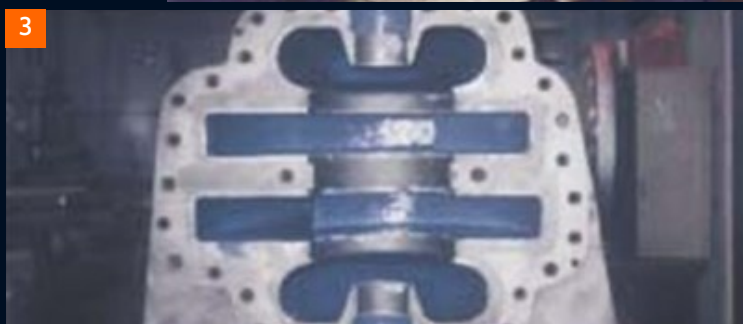
Cast iron casing / Bronze impeller

Belzona 1111 (Supermetal)  
Belzona 1341 (Supermetalgilde)
