# BELZONA KEEPS ICE CREAM FLOWING

ID: 166

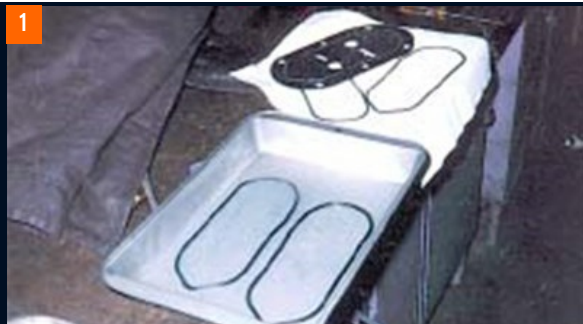
1. New gaskets glued to a cookie tin to create a mold; Belzona 9411 (Release Agent) was used in the molding process.
2. View of the mold, the plate, and the new gaskets casted from the mold.

The application was carried out in accordance with Belzona Know-How Leaflet GSS-1.

Belzona 2221 (MP Fluid Elastomer)
