# BELZONA REPAIRS SUN DAMAGE ON ROOF

ID: 168

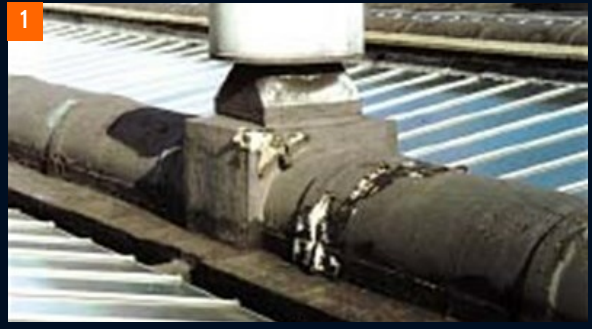
Leaks at seams, bituminous coating is damaged

The tar was severely damaged due to the effects of the sun; further application of the bituminous coating would have also failed. Belzona® 3111 (Flexible Membrane) solved the problem on the roof.

1. Failed bituminous coating
2. Seam areas addressed
3. Ducting completely protected and sealed
