# BELZONA REPAIRS COLOUR MATCH SPALLED LINTELS

ID: 1681

Spalled concrete due to rebar corrosion.

Concrete lintels.

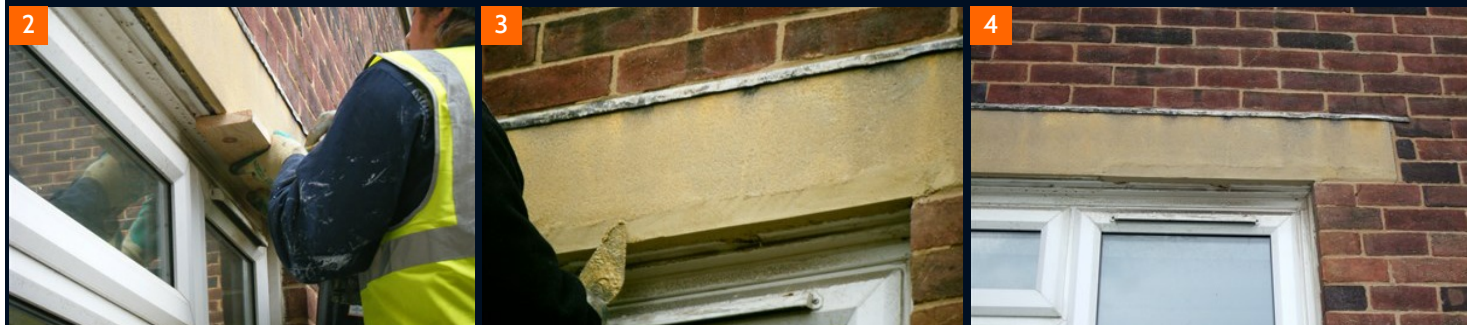
1. Spalled concrete.
2. Application in process using straight edge to form neat corner.
3. Completing the application.
4. Completed application. Note excellent colour match.

Application carried out in accordance with Belzona Know-How System Leaflet WPA-4. Belzona® 4141 was colour matched to existing concrete using Iron Oxide pigments.
