# BELZONA REPAIRS SCHOOL WALKWAY

ID: 1683

Asphalt covered concrete cantilever walkway.

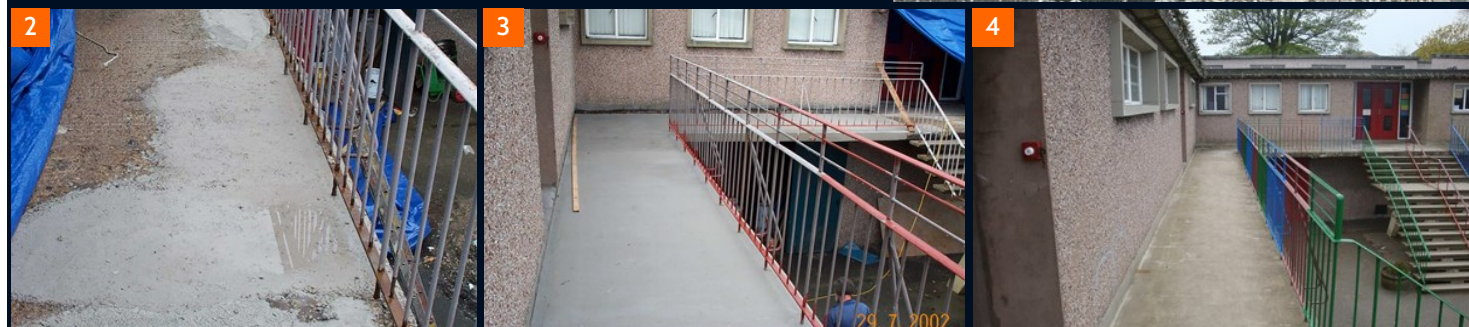
## PHOTOS

Regular application of salt had led to deterioration of the concrete beneath the asphalt. When asphalt was removed, a major structural issue was uncovered. The structural engineers at the council gave the approval for the repair.

Severity of damage revealed after grit blasting. Application of Belzona 4131 complete. Application of Belzona 5231 to entire walkway. View of application after 9 years.

Alternative: Knock it down and replace it with a steel fabricated platform to strengthen the whole building. Benefit: Work was completed during summer holidays and local authorities were delighted due to the major cost savings estimated to be around £20k minimum. Recent (2011) examination showed application to still be in excellent condition.
