# BELZONA REFURBISHES THE FLOORS

Wash area floor for aircraft food service carts

Airport Food Service in Missouri

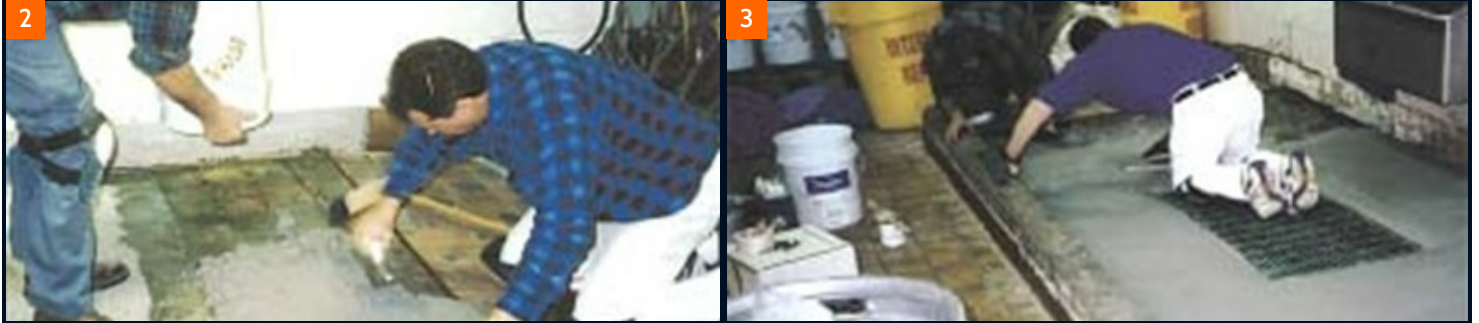
Water was trapped under the tile, causing the tile to break up and providing a haven for bacteria and mold. Pushing the carts over rough, broken, and missing tile posed a serious safety hazard as well.

1. Removing old tile, dirt and concrete
2. Beginning application of Belzona 4131 (Magma Screed)
3. Job almost completed

Old concrete was removed and 1 1/2" voids were left in several areas. Belzona® 4131 (Magma Screed) was applied over the areas where the minimum depth was 3/8". The application was carried out in accordance with Belzona Know-How Leaflet FPA-1.

The application covered a 72 square foot area and took only two hours to complete. The wash area is now a safer and cleaner place to work.
