# BELZONA SEALS TRANSFORMER BUNDING

ID: 1706

Bund for oil-filled transformer at electrical sub-station in central Sweden.

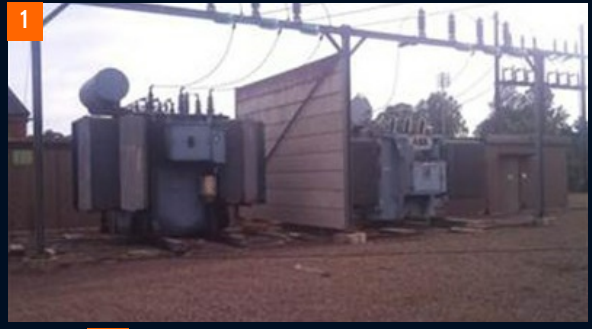
1. Transformer sub-station in central Sweden
2. Diagram of the secondary containment under the transformer. Note the glands and end plugs
3. Leaking gland
4. All penetrations were sealed with Belzona 2141

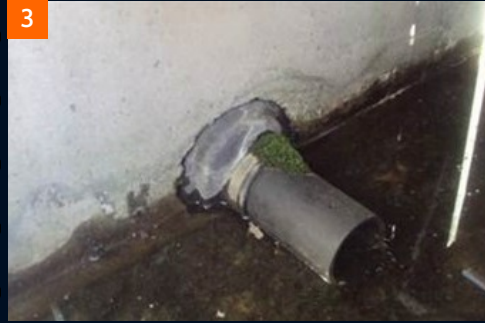
The bunding for oil-filled transformers was made up of many interconnected small concrete bunds. Connection to each bund was through polyethylene pipes. These pipe penetrations were sealed with rubber sleeves. The outer walls had polyurethane foam inserts. The glands and end-plugs were leaking since the concrete bunds were moving independently of each other. There were 32 penetrations in total with 62 sealing points on either side of the penetrations. The power company decided to seal all the pipe penetrations. The 18 end plugs in the outer wall were also replaced with Belzona.
