# BELZONA CAT BLOCK

ID: 171

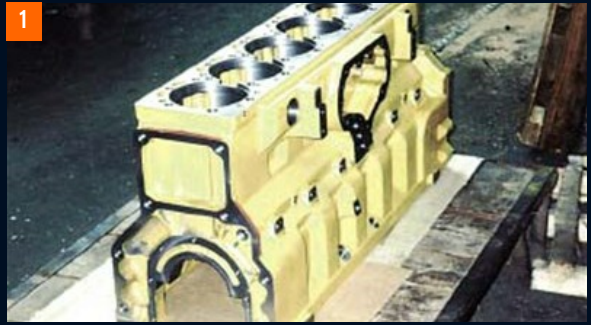
Due to a design flaw in the casting, a drilled oil passageway broke through the side of the engine block.

1. View of the engine block.
2. Close-up of broken out oil passageway.
3. Dowel pin coated with Belzona 9411 (Release Agent) in place, Belzona 1111 (Super Metal) being applied.
