# CHIMNEY SHINES WITH BELZONA PROTECTION

ID: 1717

120m high Powerstation chimney

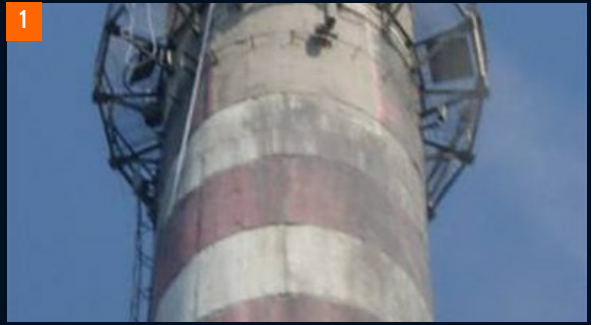
The existing coating systems had reached the end of their life and broken down resulting in an unattractive and poorly protected chimney stack. The client undertook a comparison of Belzona with a competitor.

1. September 2008 pre works
2. Application underway via rope access
3. Completed application
4. The top two, shiny bands are Belzona 5111
5. Review in 2010 - note the top two bands are still shiny

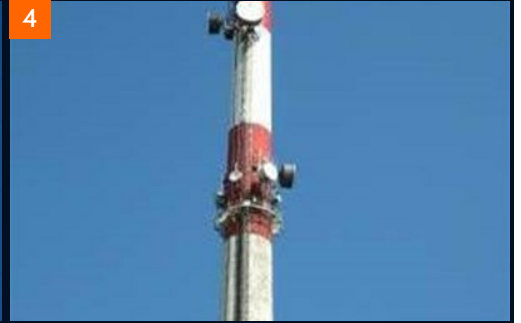
After initial review it was noted that the Belzona® 5111 quite literally outshone the competition. Aside from the chemical and UV resistance needed for the application, the smooth surface of Belzona® 5111 did not attract dirt and would "self clean" with rain.
