# LARGE GEARBOX RESTORED WITH BELZONA

ID: 1719

Large gearbox used in production of steel plate.

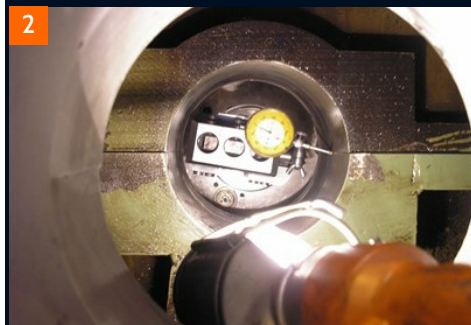
Wear in the bearing housing was causing vibration.

1. Damaged bearing housing before reconstruction
2. Accurate measuring for alignment was a key feature of the process
3. Machining after Belzona application
4. Completed application ready to work

Repairs were completed in accordance with Belzona Know-How System Leaflet MPT-6. Accurate measurements were taken to enable machining to be done in-situ to an accuracy of  $\pm 0.03\text{mm}$ .
